Indicator LEDs in the NINT Board

Following figure describes how to find the hottest phase or power plate by checking the LEDs of NINT-XX and NXPP-0X boards. This applies only to parallel connected phase modules and power plates of R8i – R12i modules.

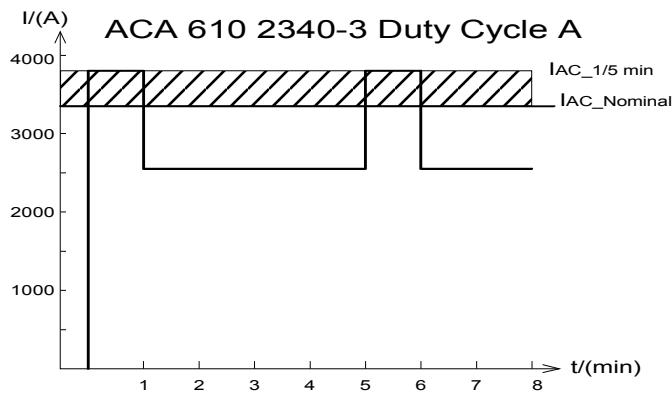
If the load current is continuously between $I_{AC_Nominal}$ and $I_{AC_1/5\ min}$, the temperature of the IGBT power plate(s) and the heat sink will increase further. The overloading time is limited by means of the temperature sensor.

Figure 7 - 4 Overloading Range between $I_{AC_Nominal}$ and $I_{AC_1/5\ min}$ in ACA 610 2340-3

If the measured temperature exceeds 115 °C, a warning “**ACS 600 TEMP**” is given and **Alarm Word 1 (AW1)** bit 4 is set to 1.

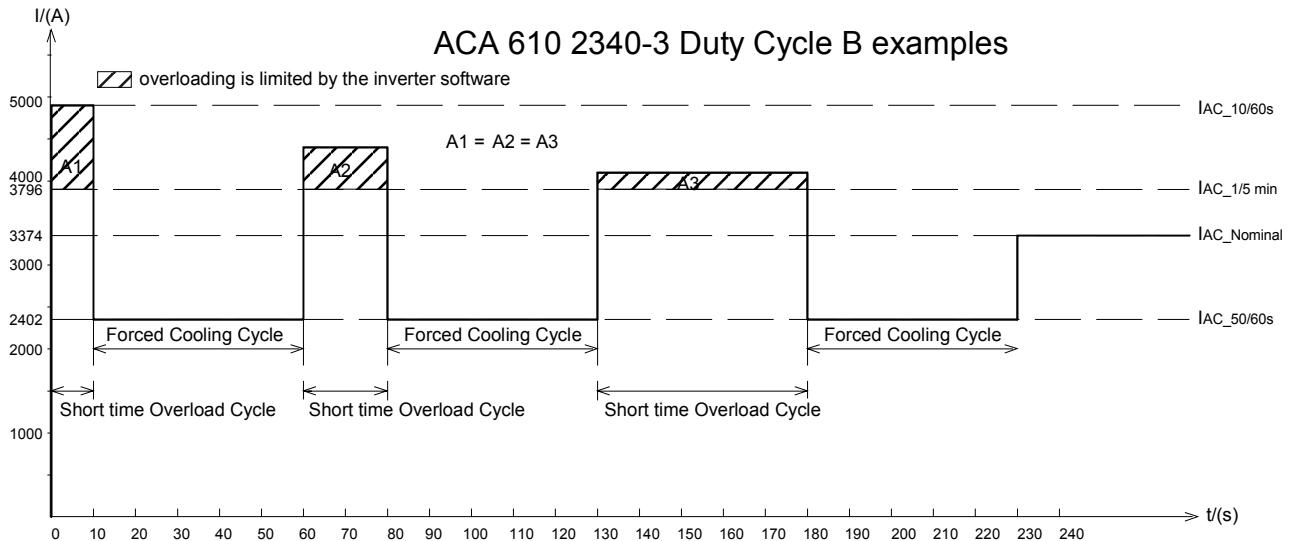
The maximum current is limited by parameter 20.04 **MAXIMUM CURRENT**. If the actual current exceeds the $I_{AC_1/5\ min}$ level, a software algorithm is also activated. The load cycle between $I_{AC_1/5\ min}$ and the maximum current is time-limited as a function of current by means of a software integrator and thus the areas of the A1, A2 and A3 are equal.

$$A1 = 10\ s * (I_{AC_10/60s} - I_{AC_1/5\ min}).$$

Figure 7 - 5 Overloading example when the Load Current is $> I_{AC_1/5\ min}$

At the beginning of a forced cooling cycle, **AW_2 (9.05)** bit 2 is set to 1 and an alarm “**INV OVERLOAD**” is given.

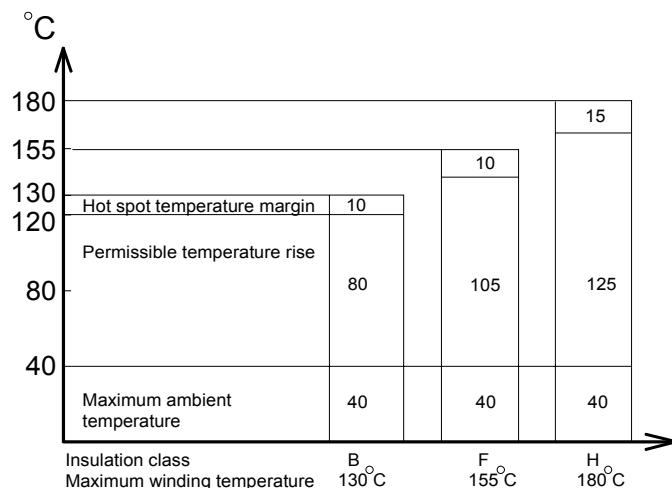
Figure 7 - 6 Motor Insulation Classes According to IEC 85

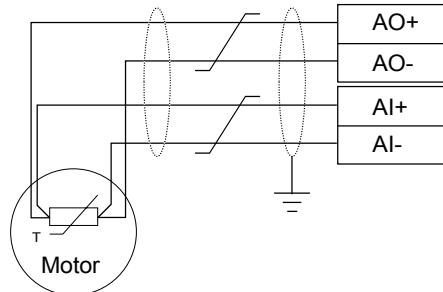
Motor temperature can be measured by using the analogue inputs and outputs of the drive. The System Application program supports two measurement channels: AI1 and AI2 for motor 1 and motor 2 temperature measurements.

WARNING! According to IEC 664, the connection of the thermistor to the analogue I/O (NIOC-01 or NAIO) or to digital input DI6 of the NIOC-01 requires double or reinforced insulation between motor live parts and the thermistor. Reinforced insulation entails a clearance and creepage of 8 mm (400/500 VAC equipment). If the thermistor assembly does not fulfil the requirement, the other I/O terminals of ACS 600 must be protected against contact, or a thermistor relay must be used to isolate the thermistor from the digital input.

Figure 7 - 7 Thermistor Connection example using Analogue I/O.

Motor overtemperature can be detected by connecting 1...3 PTC thermistors, 1...3 PT100 elements or silicon temperature sensor

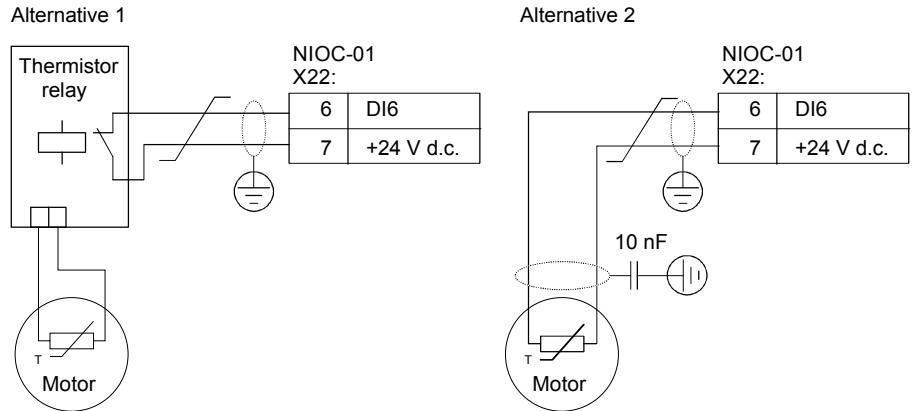
- **Note:** The thermistor can also be connected to digital input DI6 on the NIOC board according to the following figure. If direct thermistor connection is used, digital input DI6 goes to 0 false when resistance rises higher than 4 kΩ. As a result, the drive is tripped, fault “KLIXON” is activated and appended to the fault logger, and **FW_1 (09.01)** bit 5 is set to 1.

Alternative 2: At the motor end, the cable shield should be earthed through a 10 nF capacitor. If this is not possible, the shield is to be left unconnected.

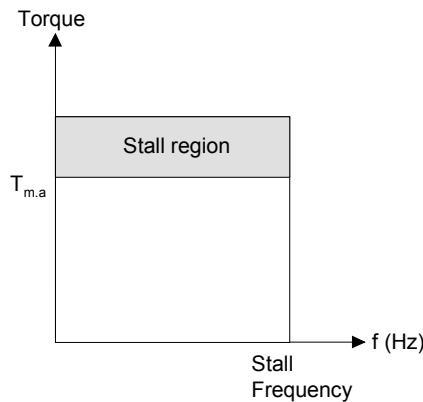
1. The ACS 600 output frequency is below the Stall Frequency limit set by the user.
2. The motor torque has risen to the maximum allowed value (the value $T_{m.a}$ in the figure) calculated by the ACS 600 application program. This limit is continuously changing depending on variables such as the motor temperature calculated by the frequency converter software.
3. Conditions 1 and 2 have been fulfilled longer than the period set by the user (Stall Time Limit).

Figure 7 - 8 Stall Protection Area

The ACS 600 drive protects the motor upon a stall situation. It is possible to adjust the supervision limits (torque, frequency, time) and choose how the drive reacts to a motor stall condition (warning indication fault indication & stop; no reaction).

An alarm or fault function can be selected by Parameter **30.13 STALL FUNCTION**. If FAULT is selected, a stall situation produces a fault “**MOTOR STALL**” and sets **FW_2 (9.02)** bit 14 to 1. If WARNING is selected, a stall situation produces a warning “**MOTOR STALL**” and sets **AW_2 (9.05)** bit 9 to 1.
